Vingtièmes journées techniques du Comité Français d'Hydrogéologie  
de l'Association Internationale des Hydrogéologues.

« Aquifères de socle : le point sur les concepts et les applications  
opérationnelles » La Roche-sur-Yon, juin 2015

# Hydrogeological prospection feedback of a hard rock aquifer in Grand Santi - French Guyana

**M. Baïset (1,2), A. Gutierrez(1), JM. Gandolfi(1), F. Mathieu(1), B. Dewandel(1), A. Boisson(1), L. Bechelen(1)**

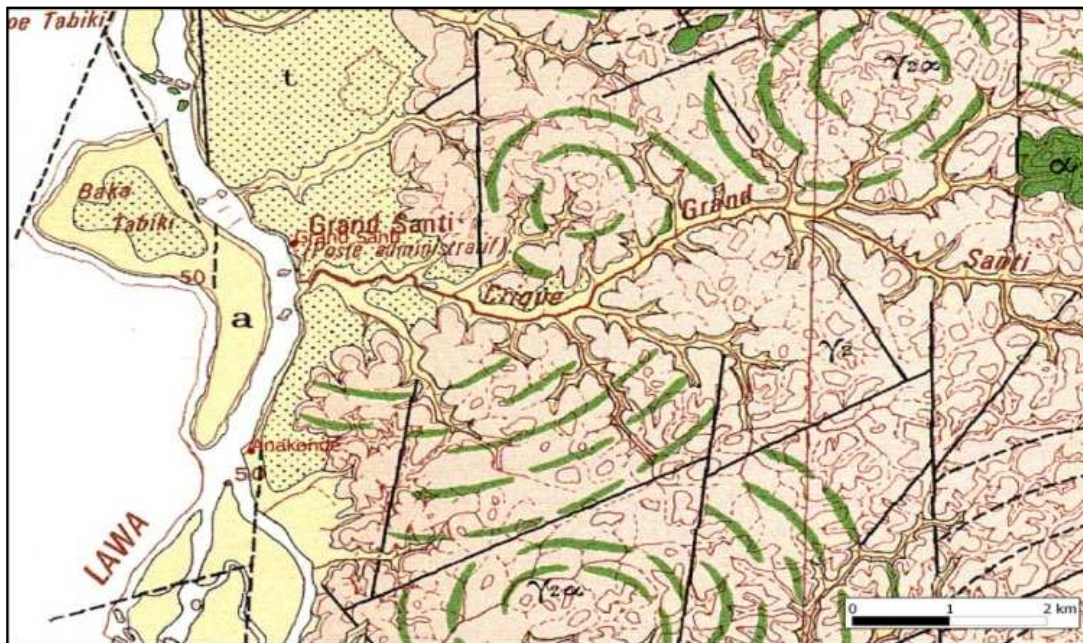
- Surrounding area of Maroni river is covered by alluviums which have a low permeability, surimposed to weathered hard rocks.
- Hard rocks are composed by Migmatites.
- Limited outcrops.
- Principal structural orientations are N340 to N20 and N100 to N140

## LÉGENDE

ω	Dolérites
γ <sub>2</sub>	Granite guyanais
γ <sub>4</sub>	Gneiss guyanais
γ <sub>α</sub>	Migmatites guyanais
h / α	Hornblendites (h), amphibolites (sensu lato) (α)
—	Failles
- - -	Directions structurales

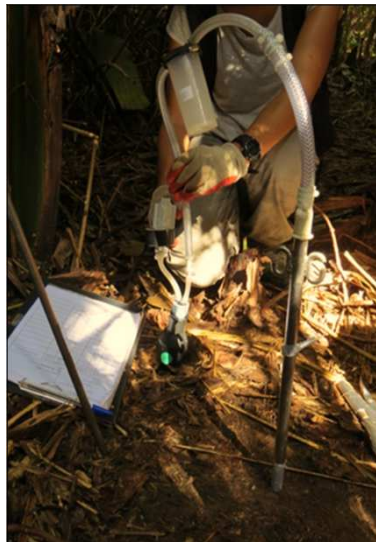
- **Phase 1** : geological field observation & structural analysis using photo interpretation
- **Phase 2** : Radon emanometry (gas sampling from the first meter of soil to detect fracture zones)

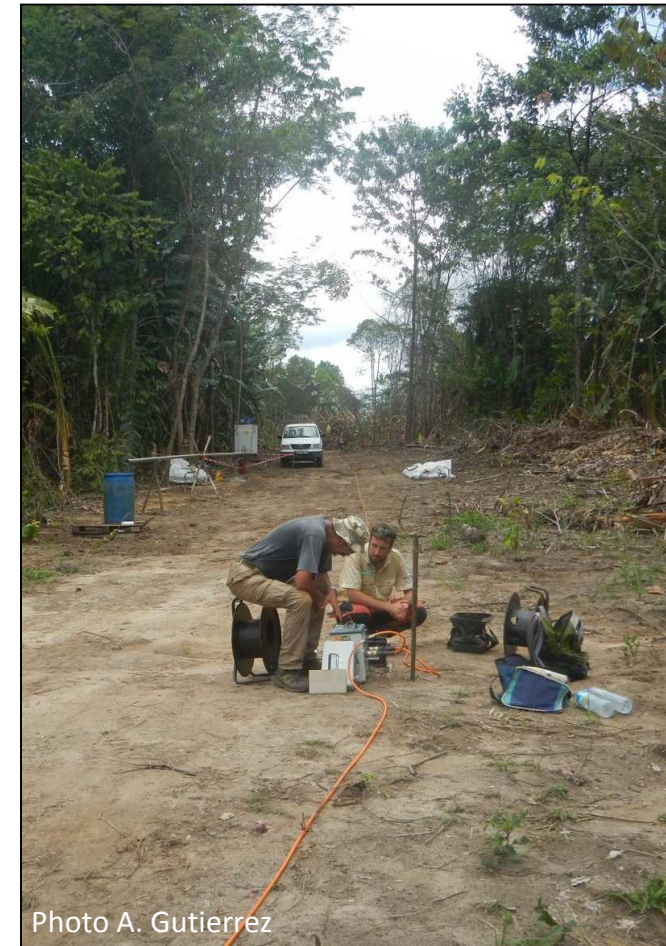
- **Phase 3** : Geophysical investigation :
  - in 1996 : geoelectrical survey (profiles and vertical soundings)
  - In 2014 : geoelectrical survey + electrical resistivity tomography (ERT)

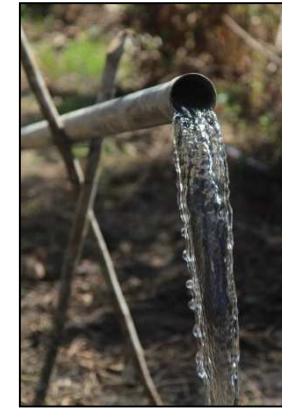
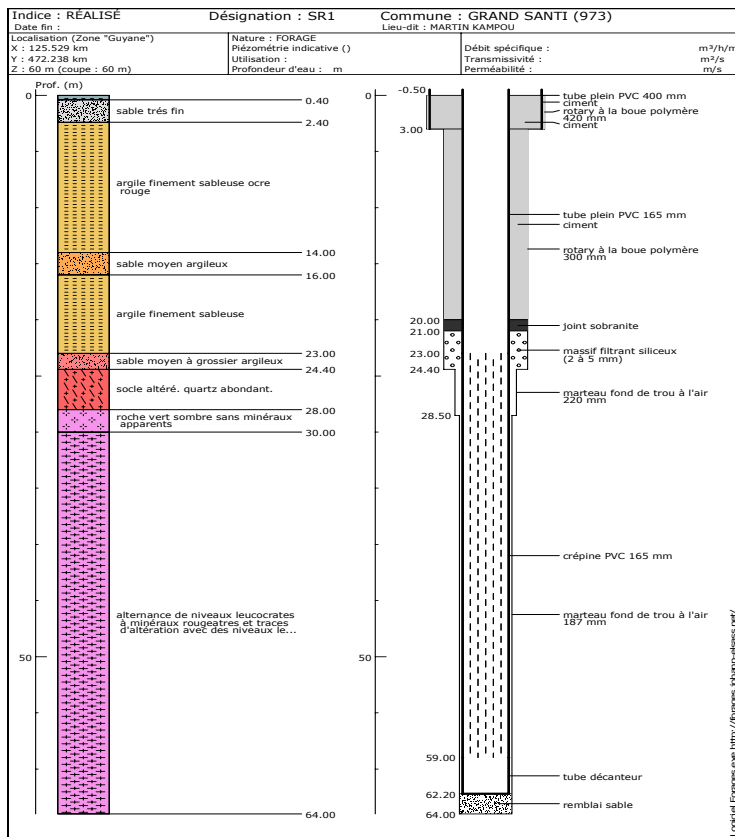
All the boreholes were drilled and equipped in the same way :

- Rotary with mud was used to drill unconsolidated formations
- Down the Hole hamer was used to drill hard rock
- Interface saprolite/fissured layer and fissured layer are screened.

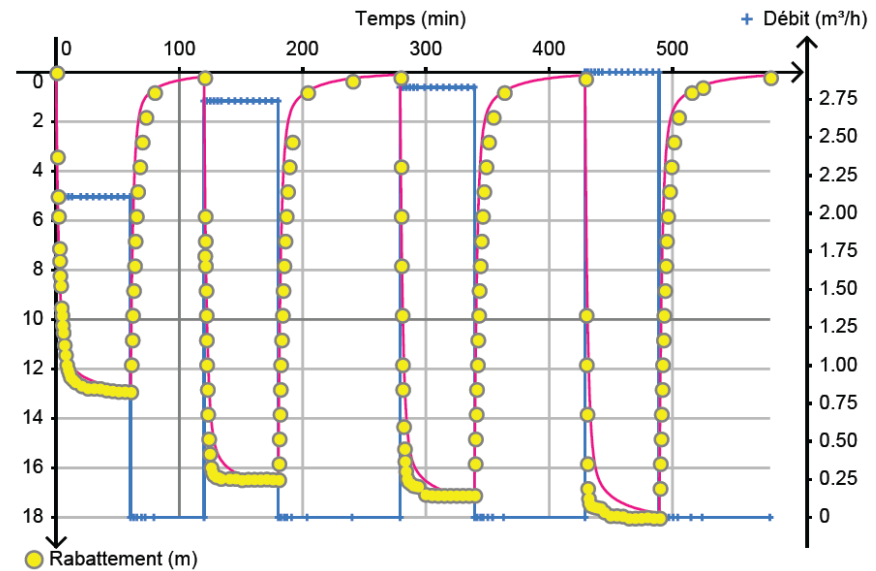
All the boreholes were submitted to hydraulic tests:

- Step drawdown test
- 72 hours pumping test

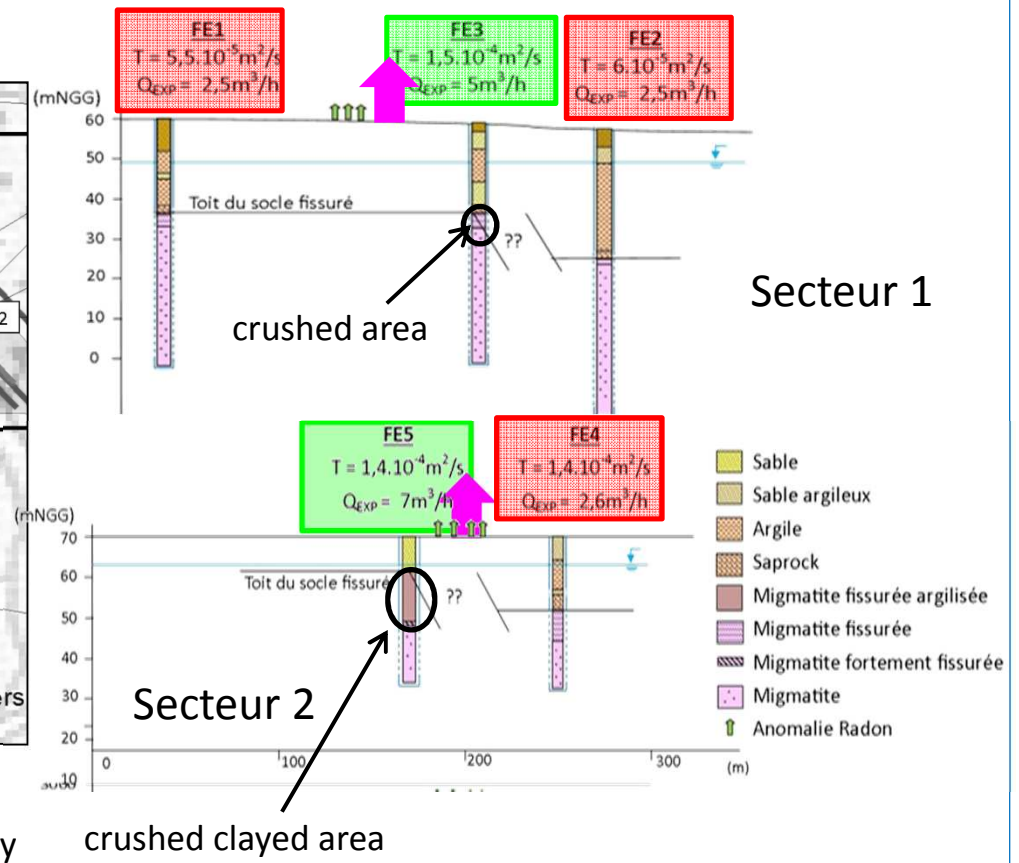
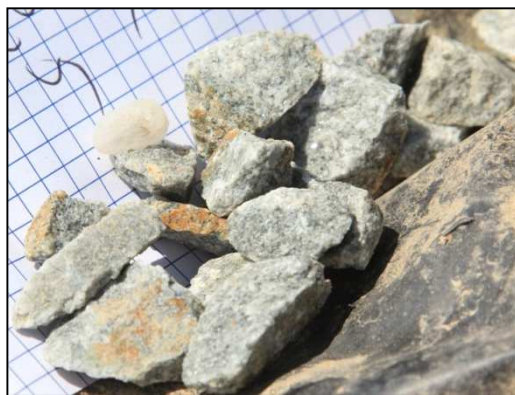
# Influence of structural discontinuity proximity on borehole productivity

Radon anomaly

Tectonics clues were found in FE5 and FE3 borehole

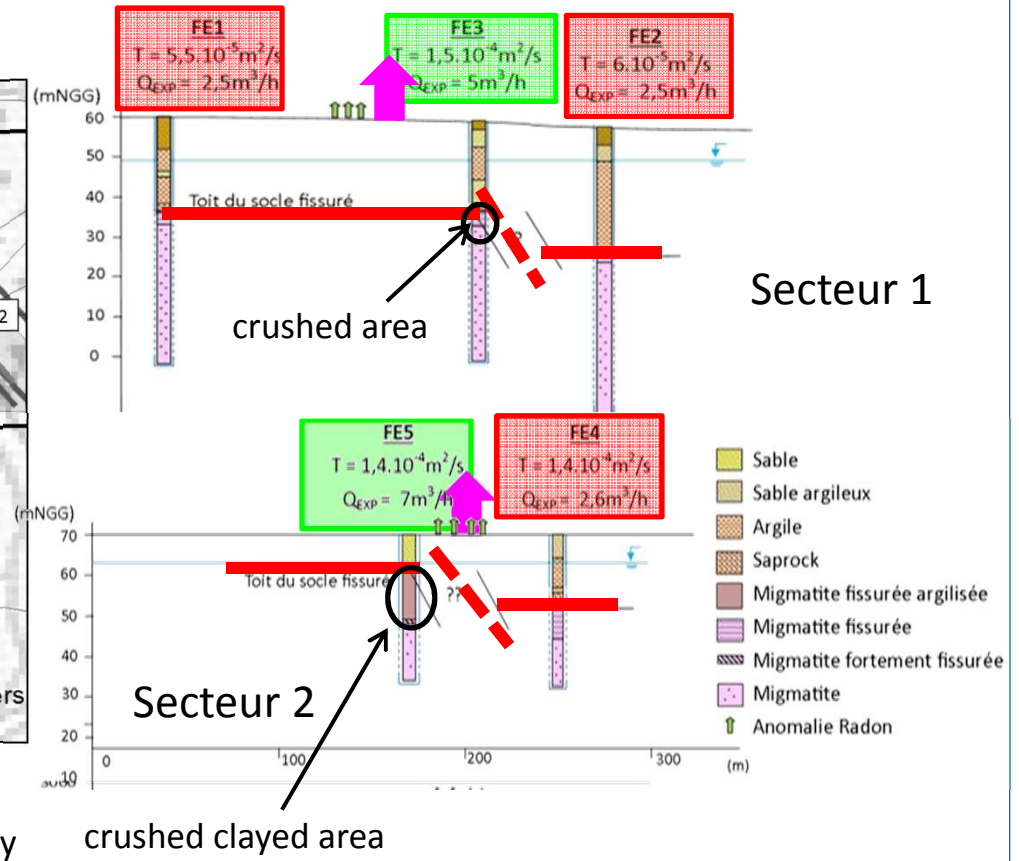
# Influence of structural discontinuity proximity on borehole productivity

Radon anomaly

Two potentials tectonics accidents

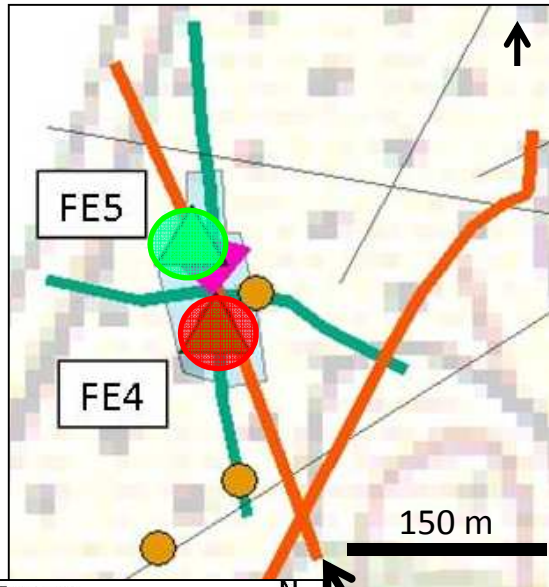
# « Sector 2 »

- Forages
- Panneau électrique
- Traîné électrique
- Sondage électrique
- prospection émanométrique
- Anomalie Radon
- Linéament
- Château d'eau

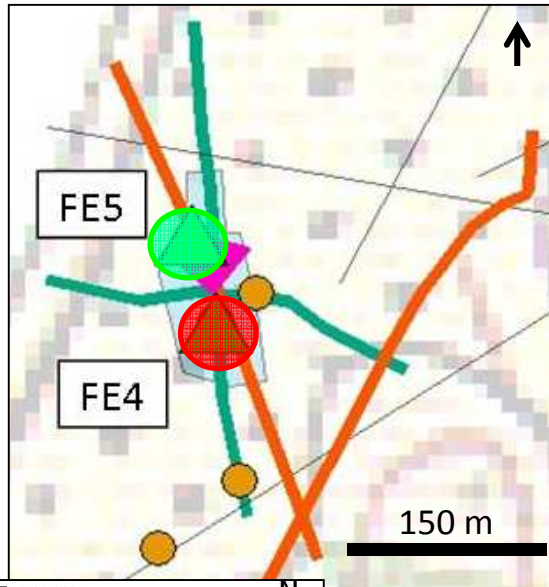
# « Sector 2 »

- Forages
- Panneau électrique
- Traîné électrique
- Sondage électrique
- prospection émanométrique
- Anomalie Radon
- Linéament
- Château d'eau

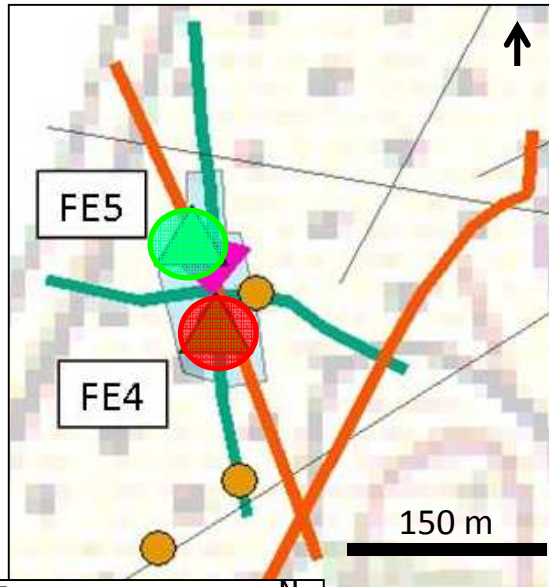
# « Sector 2 »

- Forages
- Panneau électrique
- Traîné électrique
- Sondage électrique
- prospection émanométrique
- Anomalie Radon
- Linéament
- Château d'eau

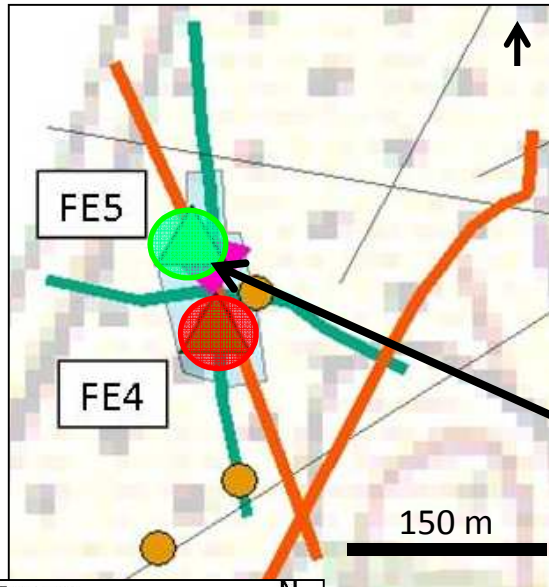
# « Sector 2 »

- Forages
- Panneau électrique
- Traîné électrique
- Sondage électrique
- prospection émanométrique
- Anomalie Radon
- Linéament
- Château d'eau

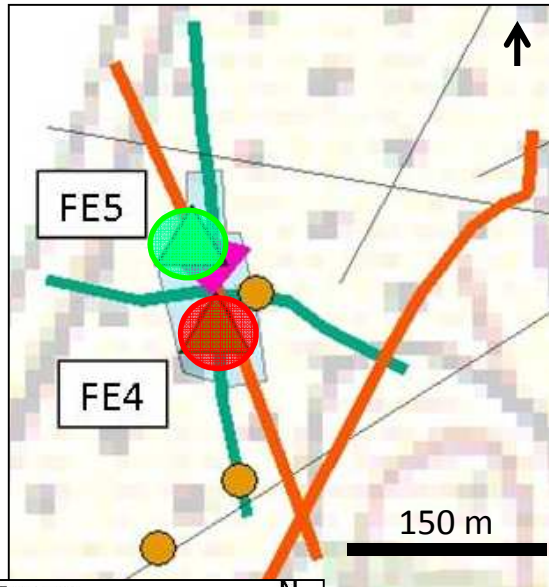
# « Sector 2 »

- Forages
- Panneau électrique
- Traîné électrique
- Sondage électrique
- prospection émanométrique
- Anomalie Radon
- Linéament
- Château d'eau

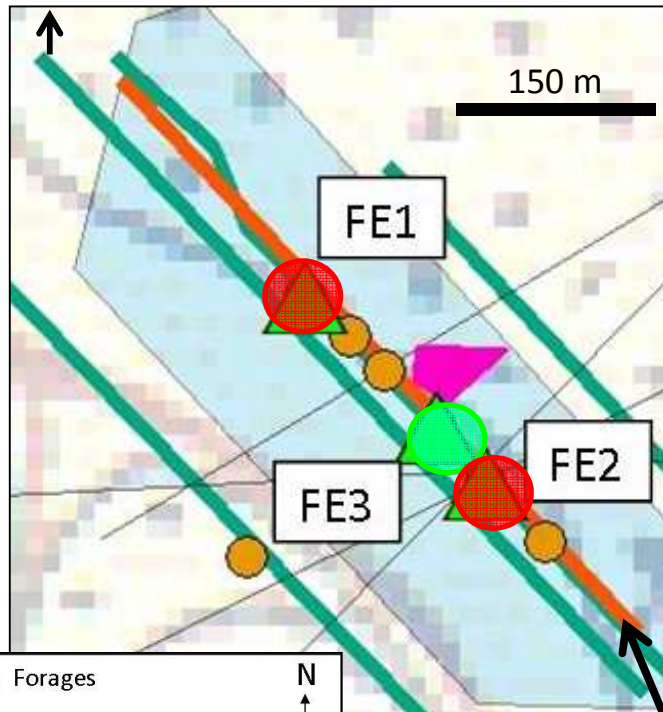
# « Sector 1 »

- Forages
- Panneau électrique
- Traîné électrique
- Sondage électrique
- prospection émanométrique
- Anomalie Radon
- Linéament
- Château d'eau

NB : ERT was performed a posteriori.

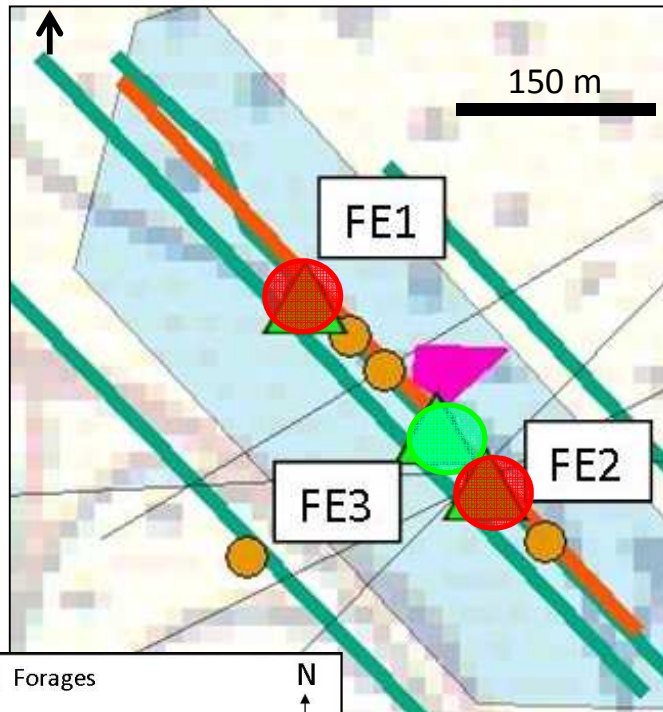
# « Sector 1 »

- Forages
- Panneau électrique
- Traîné électrique
- Sondage électrique
- prospection émanométrique
- Anomalie Radon
- Linéament
- Château d'eau

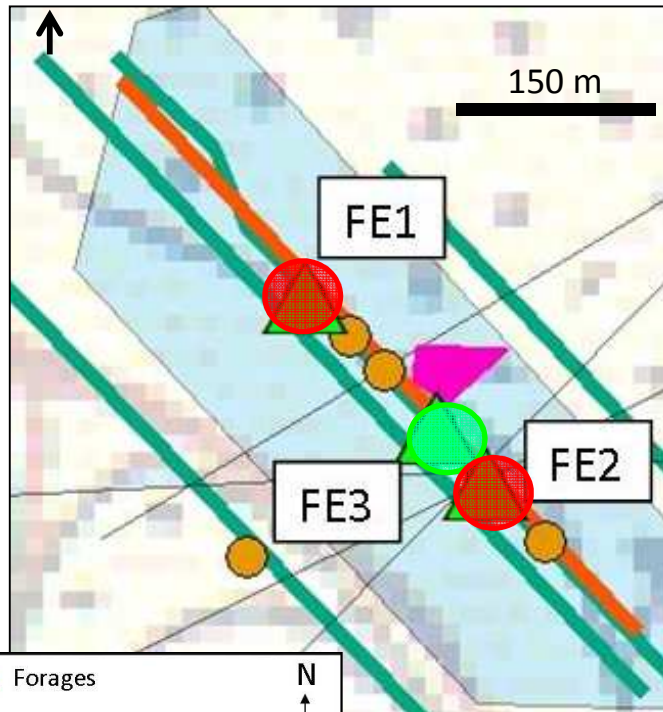
# « Sector 1 »

- Forages
- Panneau électrique
- Traîné électrique
- Sondage électrique
- prospection émanométrique
- Anomalie Radon
- Linéament
- Château d'eau

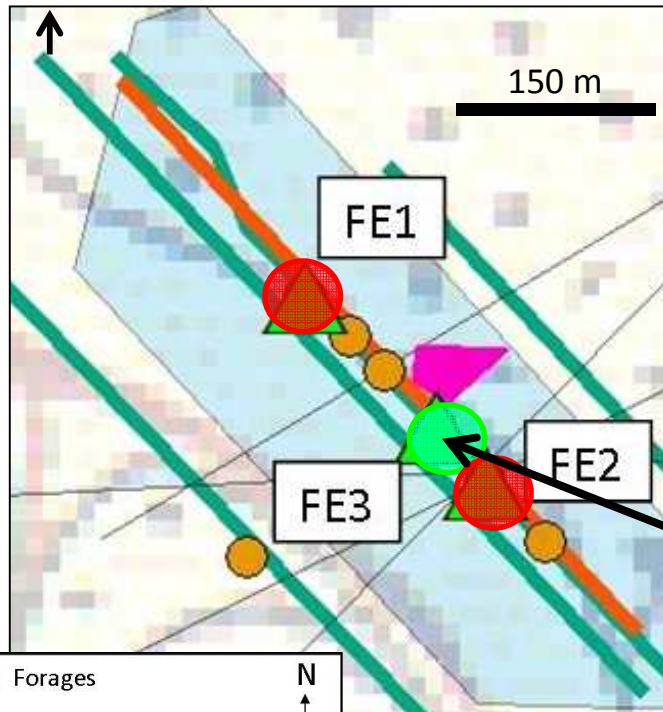
# « Sector 1 »

- Forages
- Panneau électrique
- Traîné électrique
- Sondage électrique
- prospection émanométrique
- Anomalie Radon
- Linéament
- Château d'eau

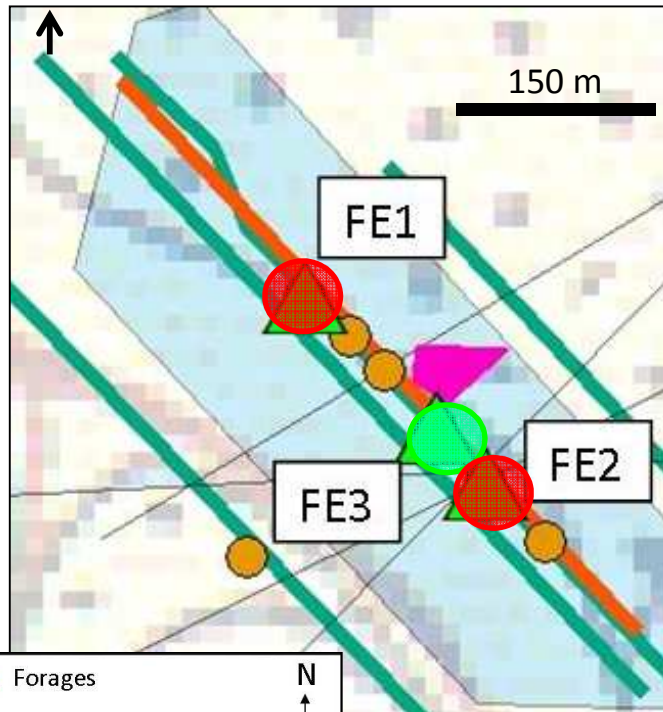
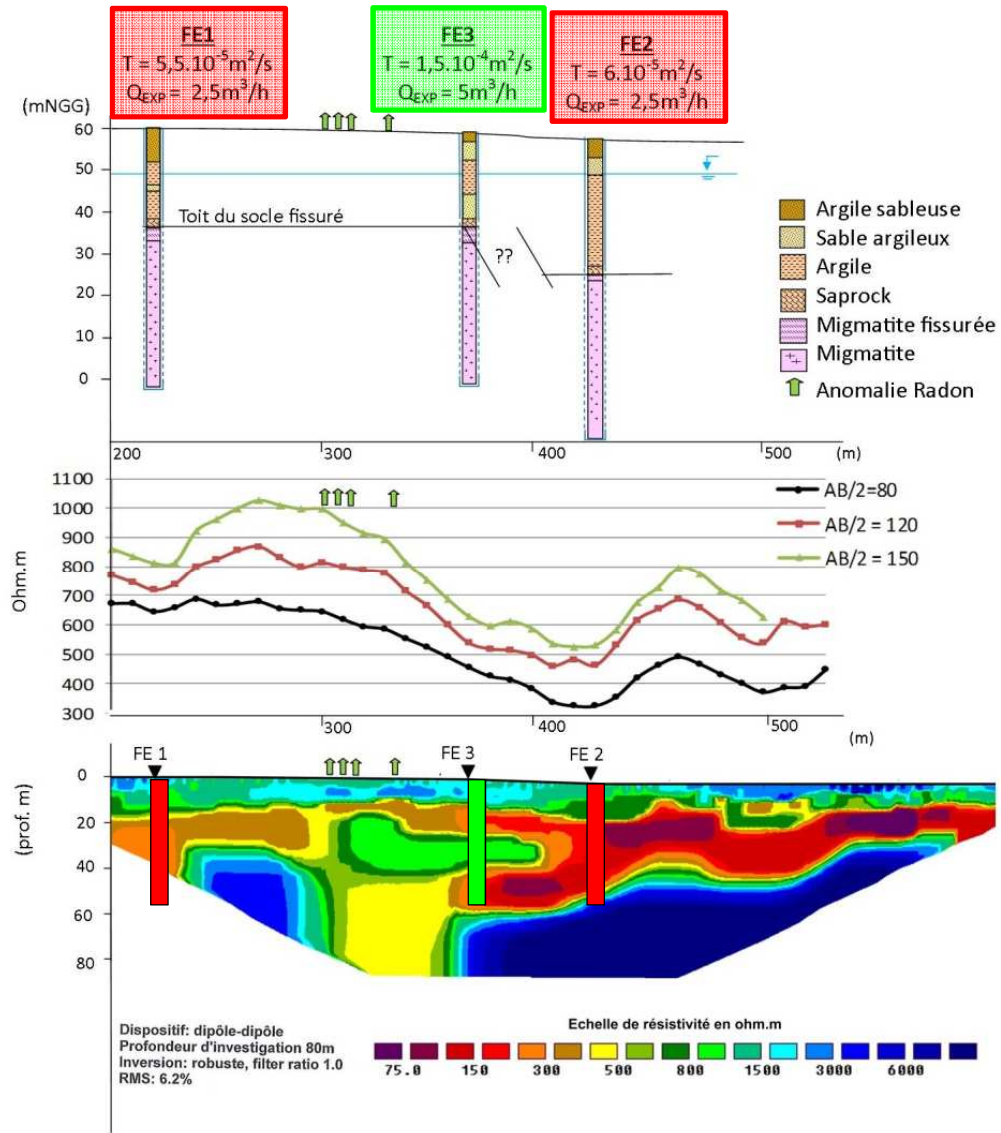
# « Sector 1 »

- Forages
- Panneau électrique
- Traîné électrique
- Sondage électrique
- prospection émanométrique
- Anomalie Radon
- Linéament
- Château d'eau

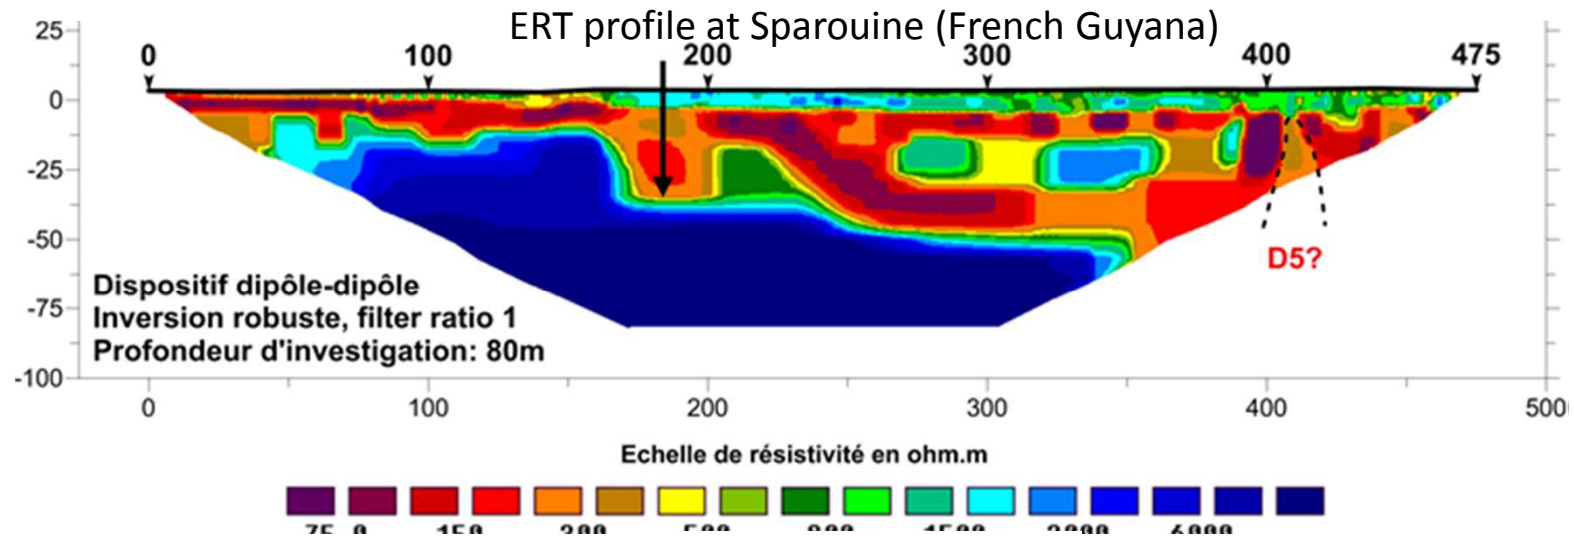
# Similar deep conductive anomalies found in other places in French Guyana

ERT profiles improve considerably the localisation of faults.
